FIRE
in a
REINFORCED CONCRETE WAREHOUSE
at
FAR ROCKAWAY, NEW YORK, U.S.A.

IRA H. WOOLSON

(10th November, 1916).

A FIRE
IN A
REINFORCED CONCRETE WAREHOUSE
AT
FAR ROCKAWAY, LONG ISLAND, N.Y., U.S.A.
BEING A REPORT PREPARED BY
IRA H. WOOLSON.

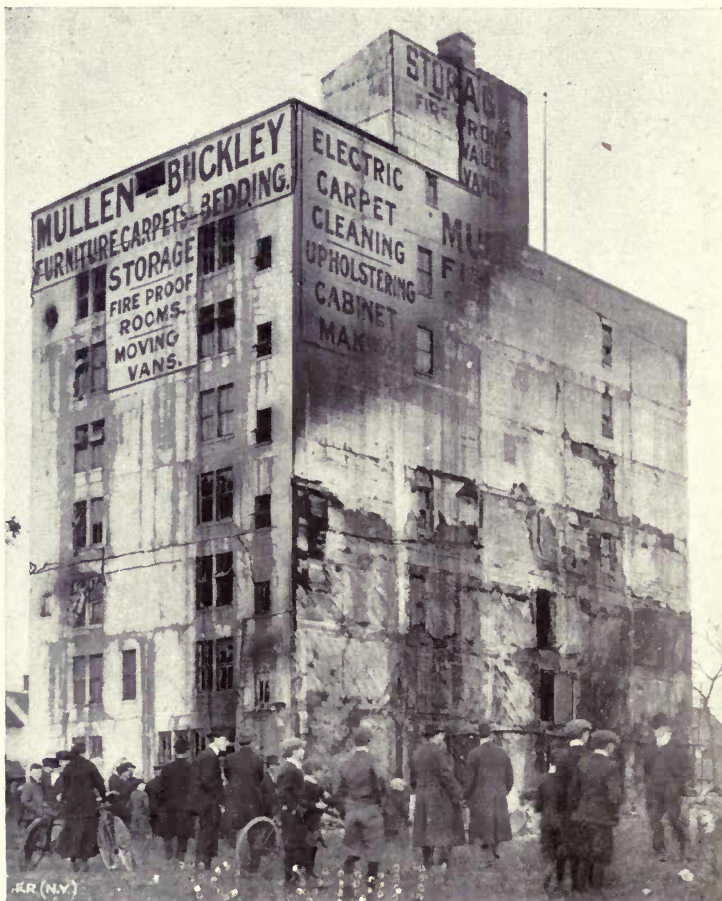
Fig. 1.--View of south and west (rear) sides of the concrete building. The frame wood-working factory was attached to the south side. Note cracks in west wall, and parapet, also fused wired glass windows in south wall, and spalled concrete. The missing fire door was removed after the fire.

The east parapet wall had no pilasters to stiffen it, and the expansion due to heat threw it outwards, making a crack at each corner $1\frac{1}{2}$ in. wide at the top and extending downward to the roof. One of these cracks can be seen in *Fig. 1*. No reinforcement could be seen in these corners.

South Exterior Wall : This wall was subjected to the full force of the fire from the burning woodworking factory and it is severely punished, as can be seen by inspection of *Fig. 1*. Large areas of the wall surface covered by the wooden building, as well as the two stories immediately above the roof, are badly spalled. Frequently these spots from which the concrete scaled are several square feet in area and 2 to 3 in. deep. The reinforcement was probably placed near the inner face of the wall as but little of it is exposed. The wall opposite the fourth and fifth stories appears to be somewhat wavy, as if it had buckled, and there are several prominent cracks. Whether any of these existed before the fire is unknown.

West Exterior Wall : This wall is buckled outwards between the third and fourth story windows an inch or more, and appears to be somewhat wavy in the stories above. There are numerous prominent cracks, one of which zigzags completely across the building. See *Fig. 1*. This injury seems to have resulted from the movement of the interior cross girders due to the settlement of the line of column No. 4 above the failure in the third story.

All the windows were broken out by firemen except a few in the row of small windows near the south-west corner, where the glass was softened by heat and dropped from the sash. See *Fig. 1*. These windows lighted the stairway shaft. The fire entered the shaft through these windows, but as there was nothing to burn, no harm ensued except to make the stairway untenable at these points. The firemen report that they entered the stairway at the fourth floor and fought the fire from it on the floors above. They reached the fourth story by ladder.

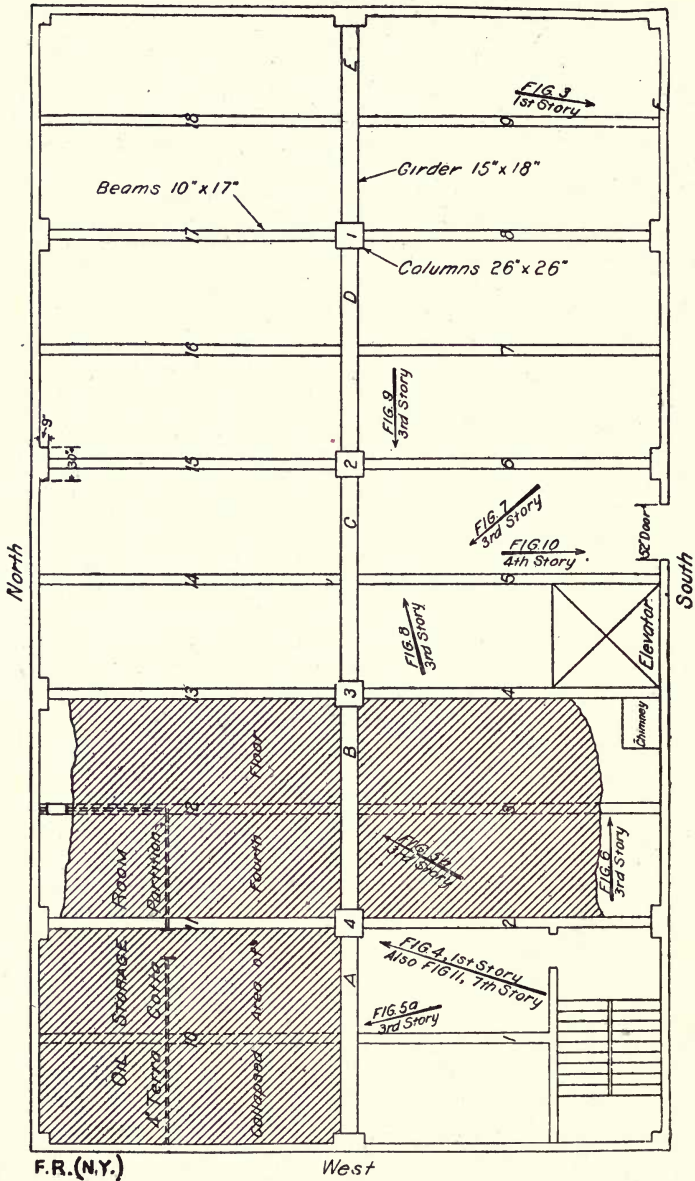
Fig. 2.—Plan of third story. All stories had the same general arrangement. Shaded area shows collapse of fourth floor. Large arrows indicate positions where photographs were taken. Beam and girder sizes are measured exclusive of floor slab.

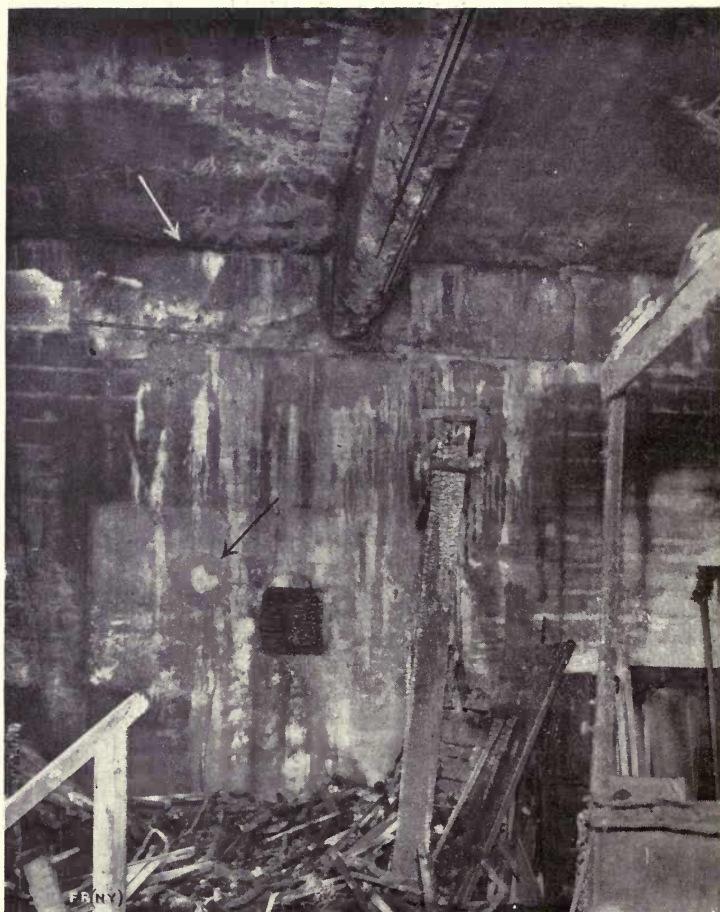
Fig. 3.—Location of small fire in south-east corner of first story. Black arrow points to hole in wall where fire entered. White arrow indicates location of hole in floor which transmitted fire to second story. Note unburned material and spalled concrete.

There was evidently a sharp, short fire here, for bits of copper wire and some thin brass were found melted, indicating a probable maximum temperature of 1,600° to 2,000° Fahr. However, the fire was confined to the small space mentioned and only partially consumed the material piled there.

The photograph is evidence of the smallness of this fire, and yet it will be noted that the wall girder is badly spalled. Chunks of concrete 8 and 10 in. thick fell from the girder, and the reinforcing bars in the bottom of the beam were exposed to 15 ft. The bars had only 1 to 1½ in. protection.

Almost directly over this hole in the wall there was a 4 in. hole in the concrete floor above it which without doubt served to convey the fire to the second story. This second hole had been left after removal of a steam heating pipe. It is an interesting coincidence that this hole in the floor should happen to be immediately over the hole in the wall which caused this small fire in the first story. In almost any other part of the floor it would have been harmless.

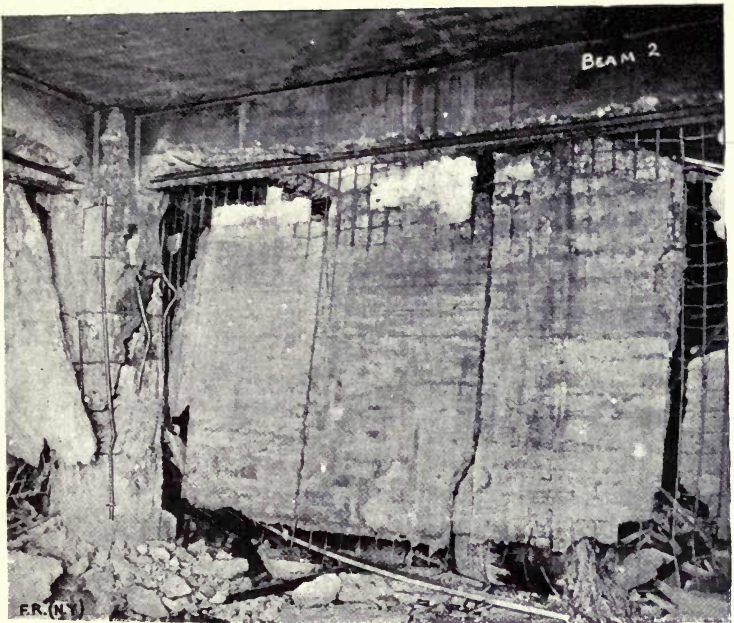
Column 4 is badly shattered and failed by diagonal shear, producing an apparent settlement of about 3 in. See *Fig. 4*.

It should be noted that lack of overlap in the slab reinforcement, previously mentioned, has allowed the concrete to break between each sheet or unit width of reinforcement, so that they hang quite disconnectedly. Evidently there could have been little unity of

Fig. 4.—View of column No. 4, girder A, and beam No. 2 in third story. Also portions of collapsed fourth floor hanging to beam in disconnected portions. Note exposed reinforcement in all members.

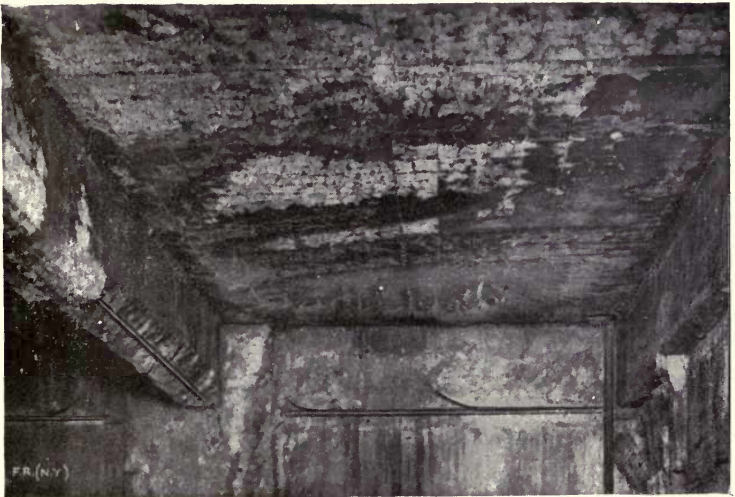
The fire was brisk in the corner east of the elevator shaft and burned considerable furniture there. *Fig. 10* shows this corner and the damage to the wall girder, pilaster column, beam No. 6 and the floor panel. All of these were badly spalled and the terra-cotta elevator partition collapsed near the top. In the south-east corner of the story there is a $\frac{1}{2}$ in. vertical crack between corner column and the adjoining wall panel.

Fig. 10.—Effect of fire corner next to elevator in fourth story. Terra-cotta elevator partition has partially collapsed. Note spalled pilaster column and wall girders, also exposed reinforcement in floor slab.

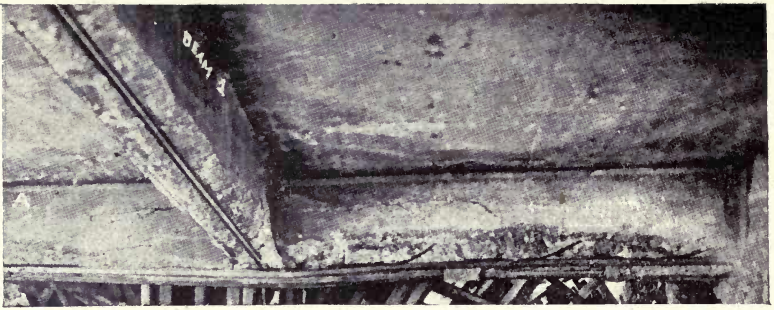
Fig. 5 shows the conditions of girders A and B. They are both badly shattered and will probably have to be replaced. The hole at the middle of girder B, near the bottom, is where the lower reinforcing bars of beam No. 3 pulled out when it collapsed. The bent-up ribbed bar projected through the girder and is still seen in place. It will be noted that the bent-up bar, intended to resist the negative bending moments, was located on a line with the bottom of the floor slab, instead of being placed near the top surface, where it would have been much more effective, and where the design drawings indicated it should be. This same defect existed in all the collapsed beams.

Girder A in third story. Note separation from floors, and diagonal cracks in girder.

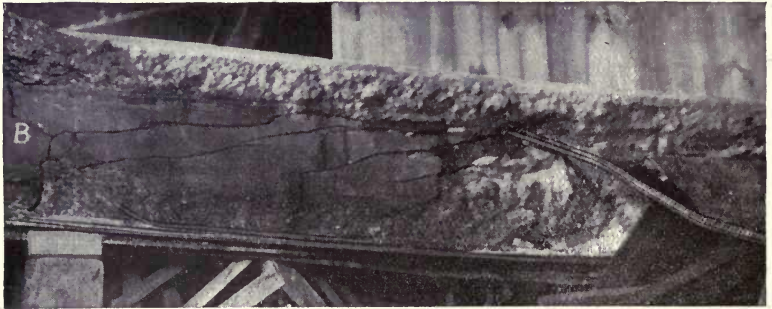
The design drawings indicate that the bent up rods, acting as negative reinforcement, should be located near the top of the floor slab, but in the beams which failed they were found in the plane of the bottom of the floor slab. This was probably detrimental. (*See Fig. 5, p. 24.*)

Girder Bin third story. The ribbed bar on the right belonged to fallen beam No. 3. The hole in bottom of girder is where the trussed bar pulled out.

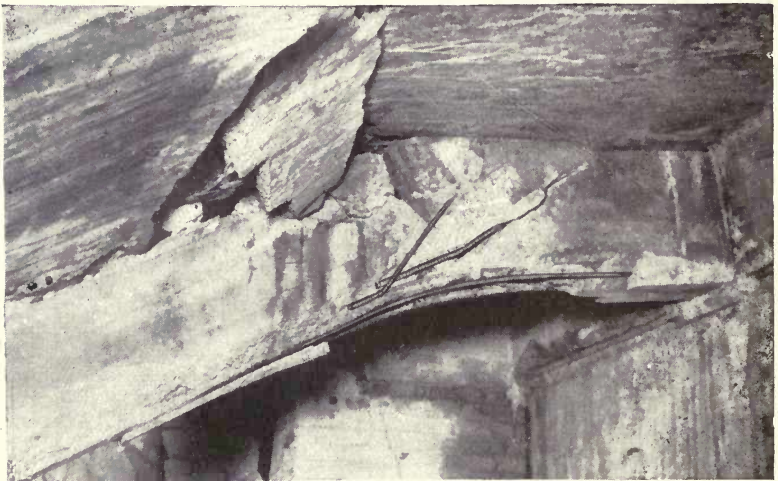
Connection of fallen beam No. 3 with wall girder in third story.
(Figs. 5 and 6.)

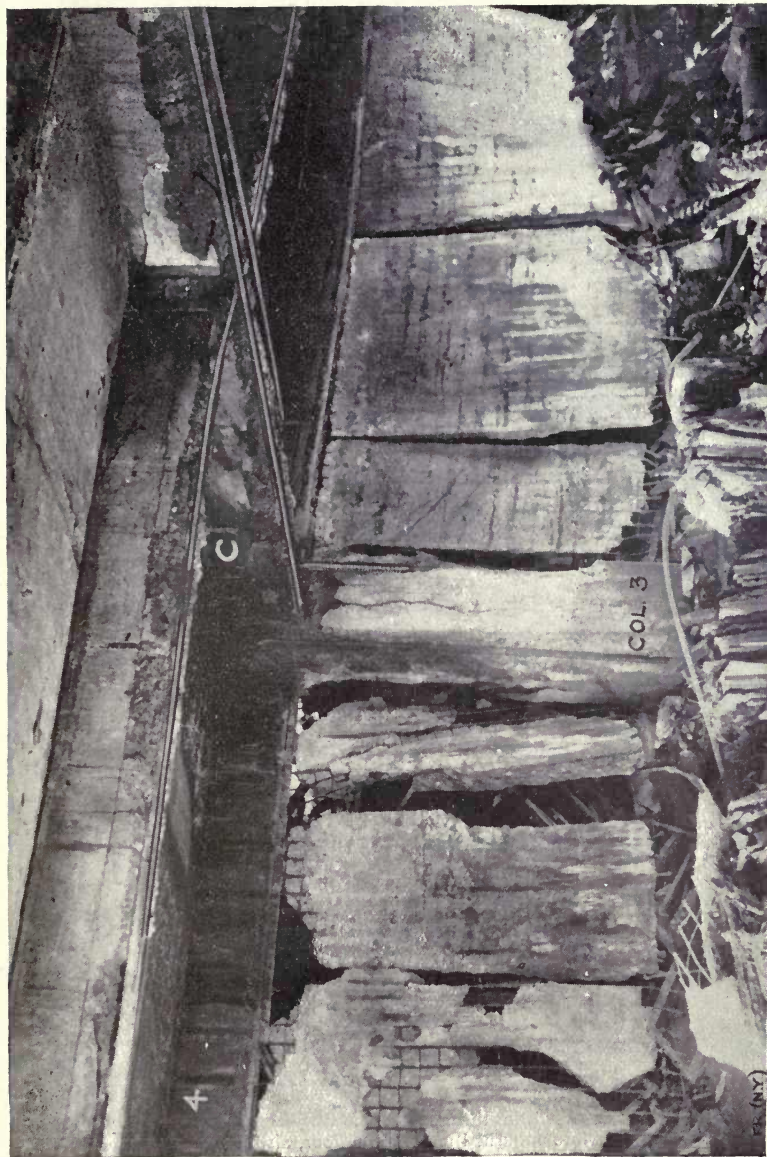
Columns Nos. 3 and 4 are badly spalled and some reinforcement is exposed and buckled, but they do not appear to have sheared or to have settled. They can probably be repaired.

All the beams and girders shown in *Fig. 7* and those in the foreground of *Fig. 8* are badly spalled and shattered. Most of them show diagonal shear cracks near the ends, and $\frac{1}{4}$ to $\frac{1}{2}$ in. cracks along the top next to the floor slabs. The fractures indicate that the beams and floor slabs were cast monolithic; it is therefore not quite clear why these cracks occurred unless due to unequal expansion of beams and floor slabs. Possibly the rapid expansion of the lightly loaded floor being resisted by the beams from deflecting downwards arched upwards and broke connection with the beams by overcoming the tensile strength of the concrete.

Fig. 7.—Looking westward in third story showing column No. 3 with connecting beams and girders, also hanging floor slabs broken away from fallen beams Nos. 3 and 12. Note disconnected slab units, spalled concrete, and exposed reinforcement. *page 25*

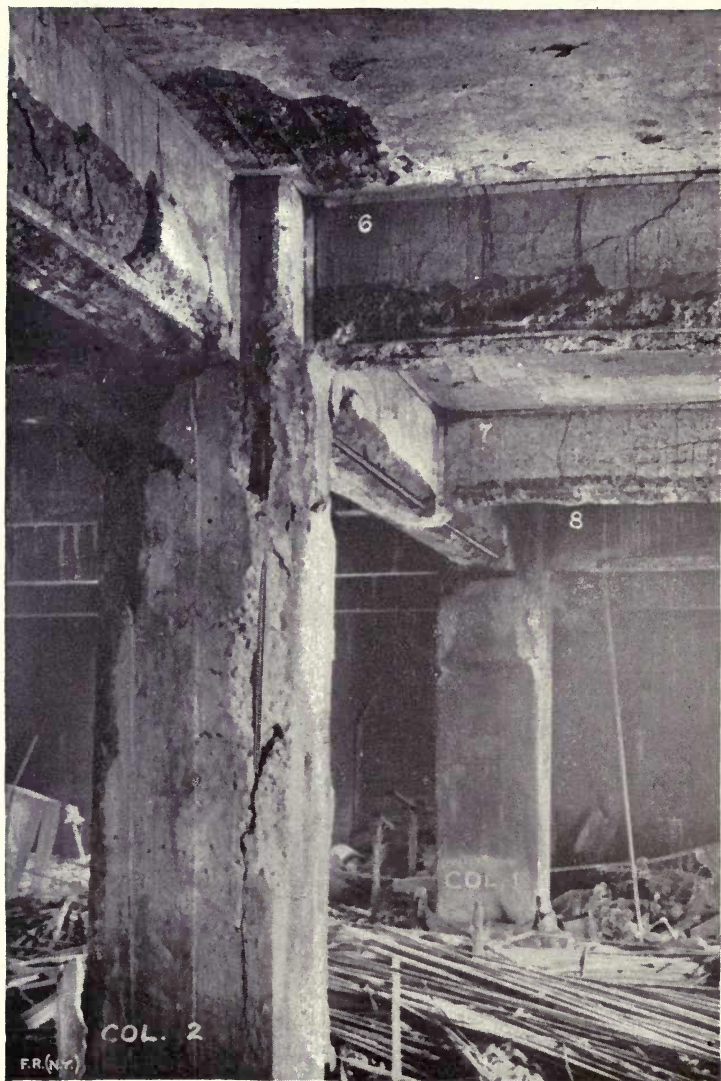
Fig. 8.—Looking eastward in third story, showing character of injury to concrete. Note unburned material on floor, also in Fig. 7.

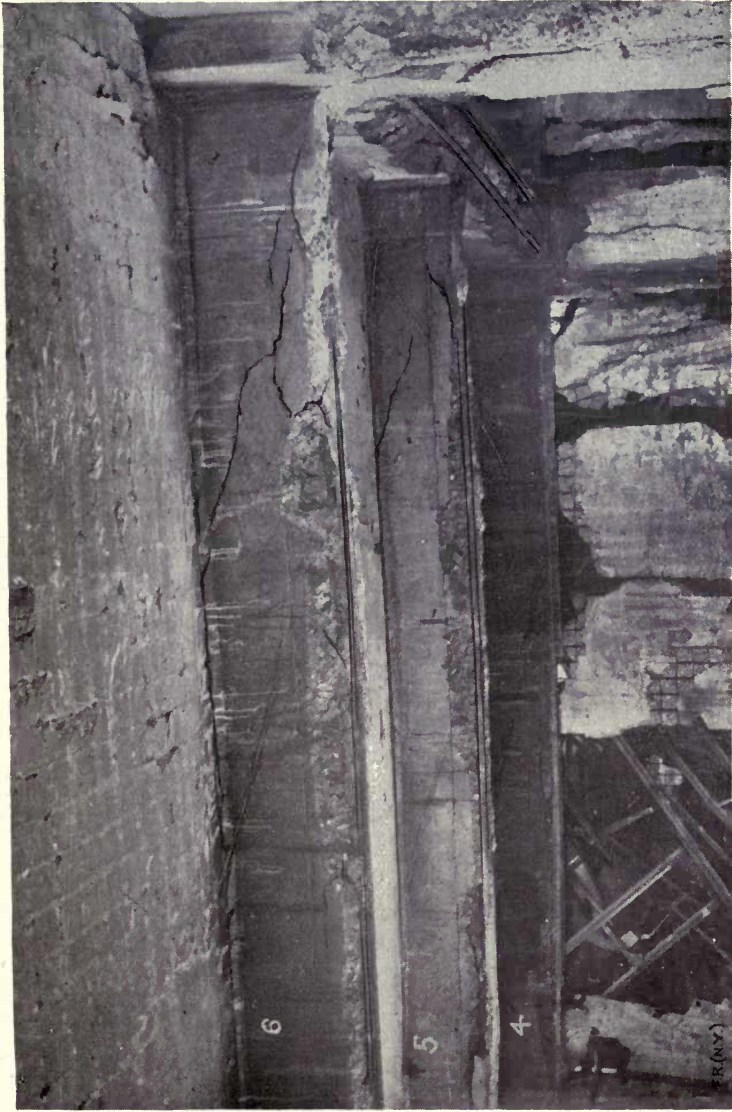
Fig. 9 shows details of these cracks in two of the beams. Considerable settlement has occurred in several of these members, and it is probable that they will have to be replaced or be substantially strengthened, as was done in repair of beams at the Edison plant.

Fig. 9.—Details of fractures in beams Nos. 4, 5, and 6 in third story. Note separation of beams from floor slab. page 27

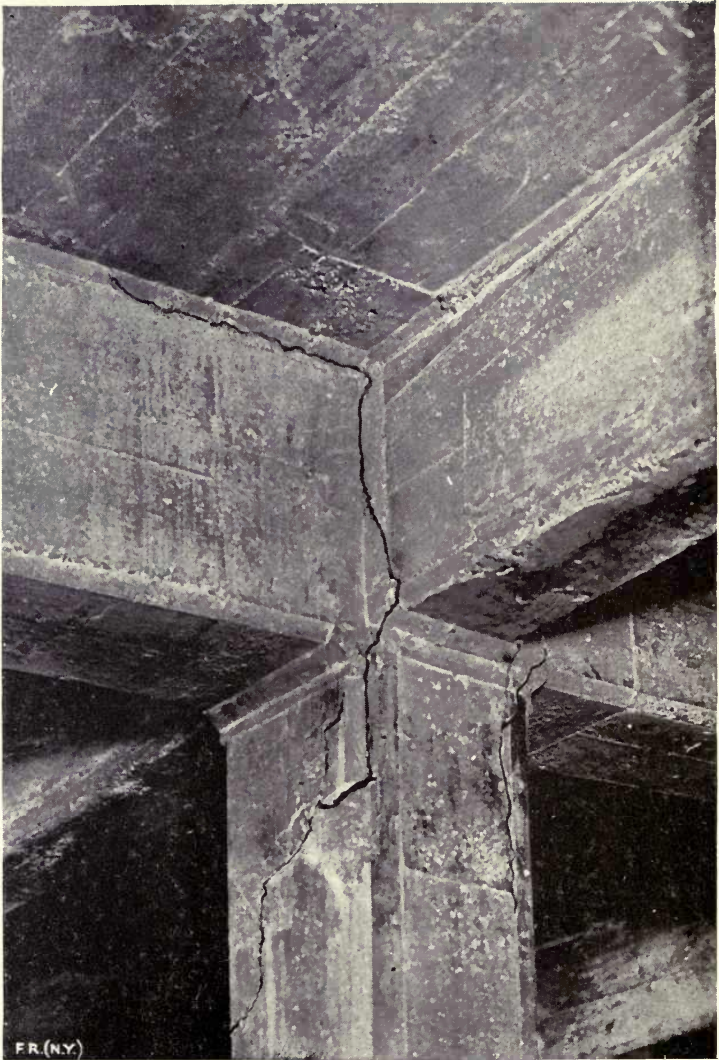
Structural damage limited to settlement of column No. 4, producing large cracks at the top. There are also some prominent cracks in wall girder F in the south-east corner.

Fig. 11.—Top of column No. 4 with connecting beams and girders in seventh story. Note cracks due to settlement of column.
